Manhole Inspection Summary

Manhole # S17Q__014MH

Insp Date: **4/14/08 11:37 AM**

Location Address: **2641 wilkens-cole alley**

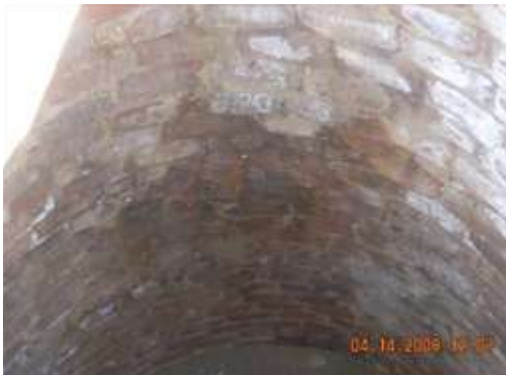
Defect 2

Infiltration: ☐ None ☐ Joint ☐ Cracks ☒ Mortar ☐ Roots ☒ Wall

infiltration @ barrel wall

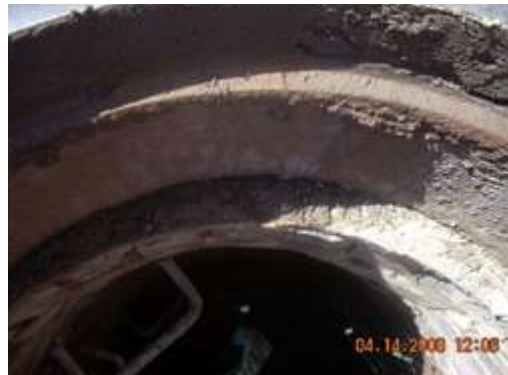
Defect 1

Frame Offset: **1** (in.) Condition: ☒ Sound ☐ Cracked ☐ Leaks

frame offset

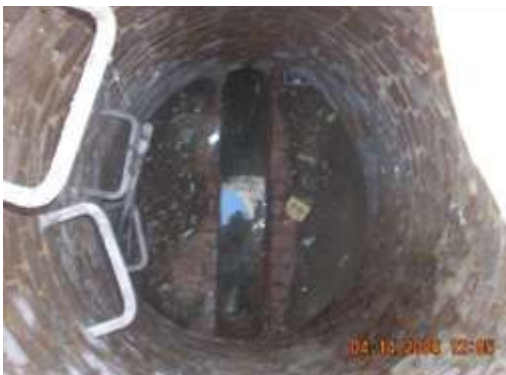
Defect 3

Condition: ☐ Sound ☐ Cracked ☐ Root Intrusion ☐ Deteriorated ☐ Leaks ☒ Debris

bench cond debris

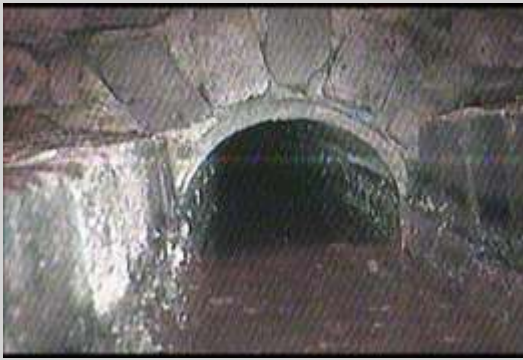
12 O'Clock Outflow

8 in. Circular Gravity Sewer
Pipe Out @ 12 O'Clock

Pipe Height: **8.4** (in.) Rod and Bar (Angled)
Pipe Material: **Clay** ☐ Pipe Lined
Invert Depth: **9.08** (ft.) Flow Characteristics: **Slow**
Deposits: ☒ None ☐ Mud ☐ Sludge ☐ Debris ☐ Grease
Silt Depth: **0** (in.) Deposits Extent:
Infiltration: **None** Pipe Seal Cond: **Sound**

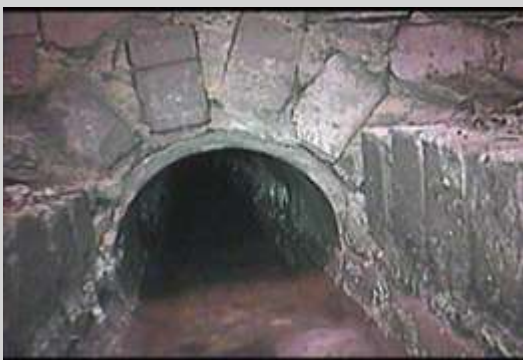
6 O'Clock Inflow

8 in. Circular Gravity Sewer
Pipe In @ 6 O'Clock

Pipe Height: **8.4** (in.) Rod and Bar (Angled)
Pipe Material: **Clay** ☐ Pipe Lined
Invert Depth: **9.05** (ft.) Flow Characteristics: **Slow**
Deposits: ☒ None ☐ Mud ☐ Sludge ☐ Debris ☐ Grease
Silt Depth: **0** (in.) Deposits Extent:
Infiltration: **None** Pipe Seal Cond: **Sound**
